INDOOR AIR QUALITY ASSESSMENT

**Joseph J. Hurley Elementary School
70 Worcester Street, South End
Boston, Massachusetts**

Prepared by:
Massachusetts Department of Public Health
Bureau of Environmental Health Assessment
Emergency Response/Indoor Air Quality Program
August 2004

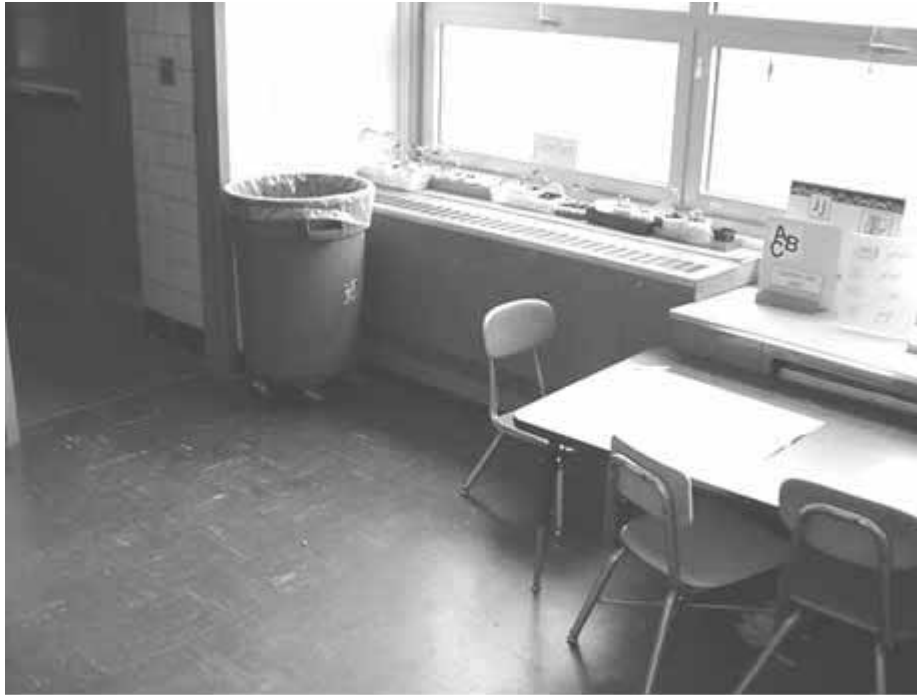
Picture 1

Fresh air in classrooms is supplied by a unit ventilator (univent) system ([Picture 1](#)). A univent draws air from outdoors through a fresh air intake located on the exterior walls of the building and returns air through an air intake located at the base of the unit (Figure 1). Fresh and return air are mixed, filtered, heated and provided to classrooms through a fresh air diffuser located in the top of the unit. Univents were found deactivated in many classrooms throughout the school (Picture 2). Obstructions to airflow, such as materials

stored on top of univents or furniture located in front of univents, were also observed in a number of classrooms (Pictures 1 and 3). In order for univents to provide fresh air as designed, these units must remain “on” and allowed to operate while rooms are occupied. In addition, intakes must remain free of obstructions.

Plants in several classrooms were found on top of univents (Picture 1). Plants, soil and drip pans can serve as sources of mold growth, thus plants should be properly maintained. Over-watering of plants should be avoided, and drip pans should be inspected periodically for mold growth. Plants should also be located away from univents and ventilation sources to prevent aerosolization of dirt, pollen or mold.

Univent, note blockage by trash barrel and location of plants

3. Remove all blockages to univents and exhaust vents.
4. Consider having ventilation systems re-balanced every five years by an HVAC engineering firm.
5. Use the principles of integrated pest management (IPM) to rid the building of pest. Activities that can be used to eliminate pest infestation may include the following activities.

8. Clean catch basins for water coolers periodically to prevent microbial growth.
9. Move plants away from univents in classrooms. Ensure all plants are equipped with drip pans. Examine drip pans for mold growth and disinfect areas of water leaks with an appropriate antimicrobial where necessary. Consider reducing the number of plants.

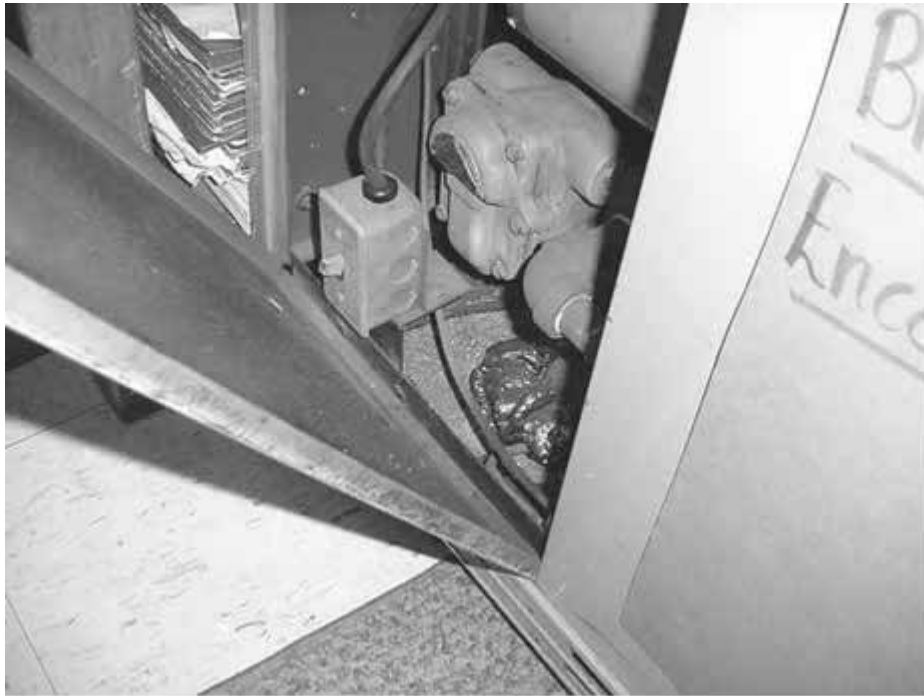
Picture 2

Univent turned 'off'

1. Operate both supply and exhaust ventilation continuously during periods of school occupancy independent of classroom thermostat control.
2. Examine each univent for function. Survey classrooms for univent function to ascertain if an adequate air supply exists for each room. Operate univents while classrooms are occupied. To increase airflow, set univent controls to “high”. Consider

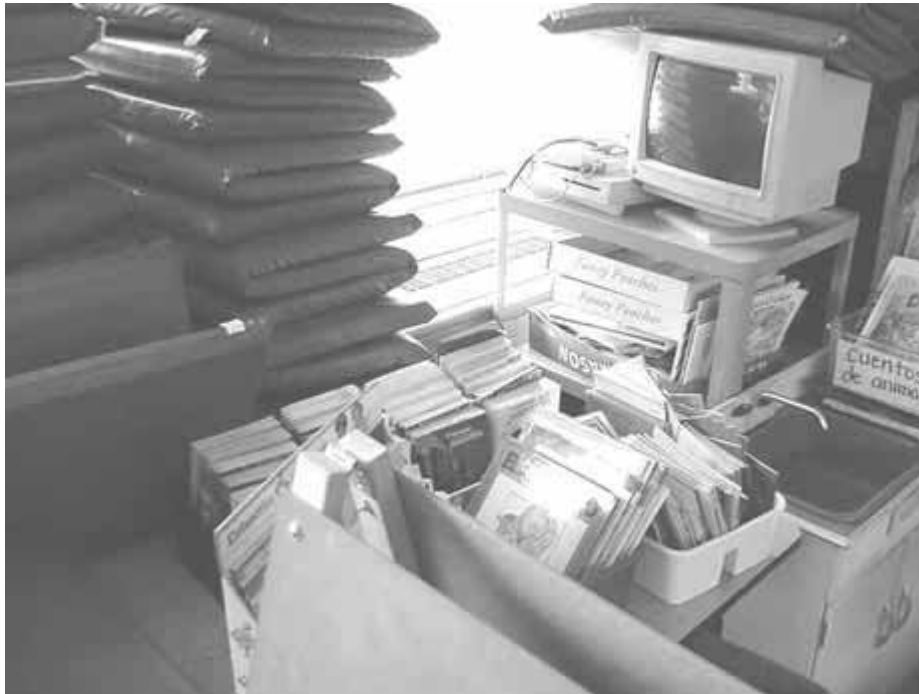
Picture 3

Blocked univent

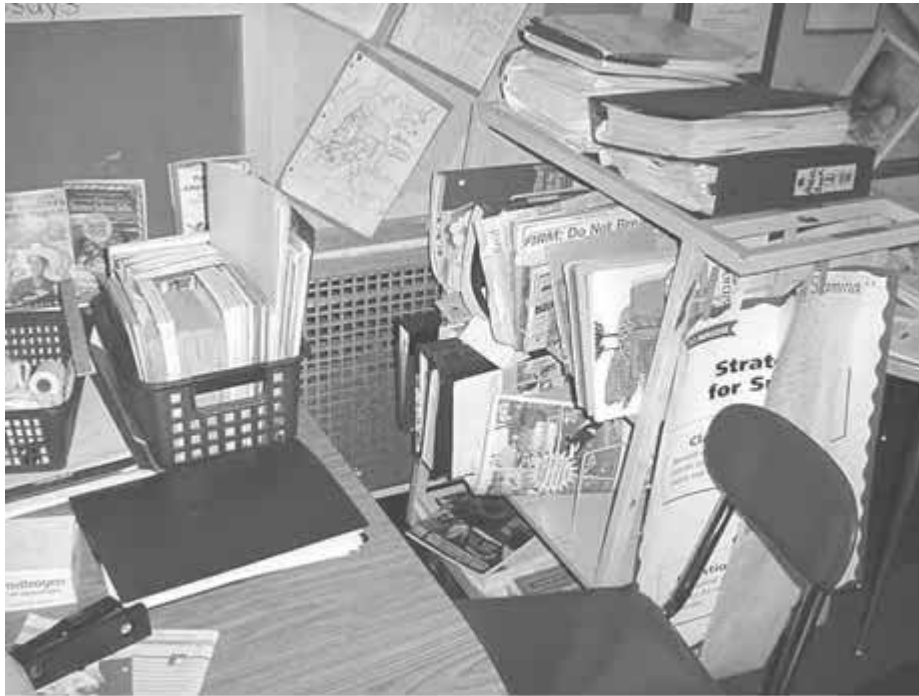
Picture 4

The mechanical exhaust ventilation system consists of wall-mounted exhaust vents connected to rooftop exhaust fans. In a number of classrooms, wall-mounted exhaust vents were blocked by desks, cabinets and other furniture (Picture 4). In other cases, wall vents were located behind classroom doors (Picture 5). As with the univents, in order for exhaust ventilation to function as designed, exhaust vents must remain free of obstructions.

Blocked exhaust vent

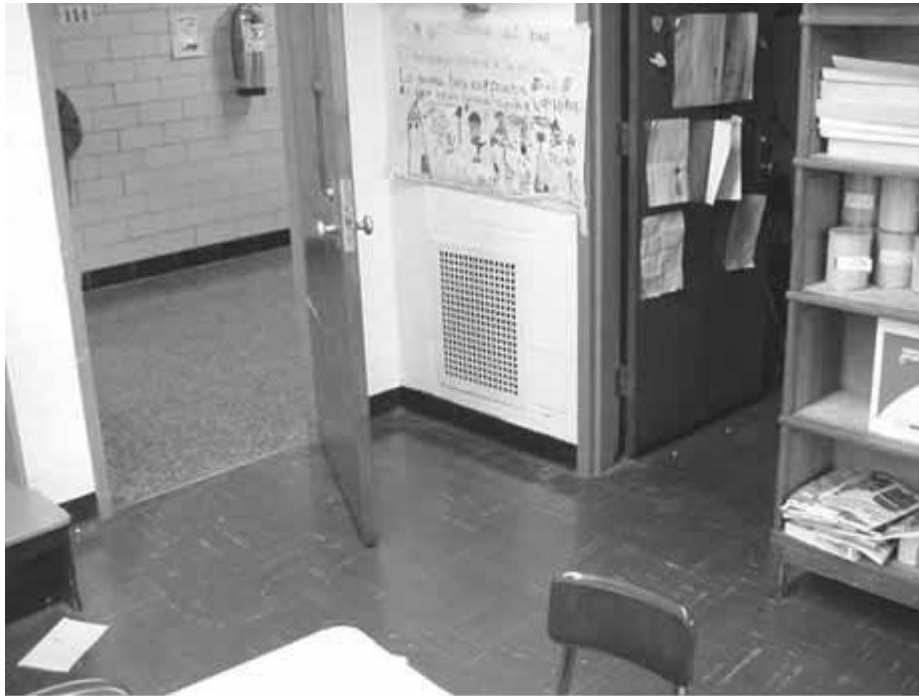
Picture 5

Exhaust vent located behind door

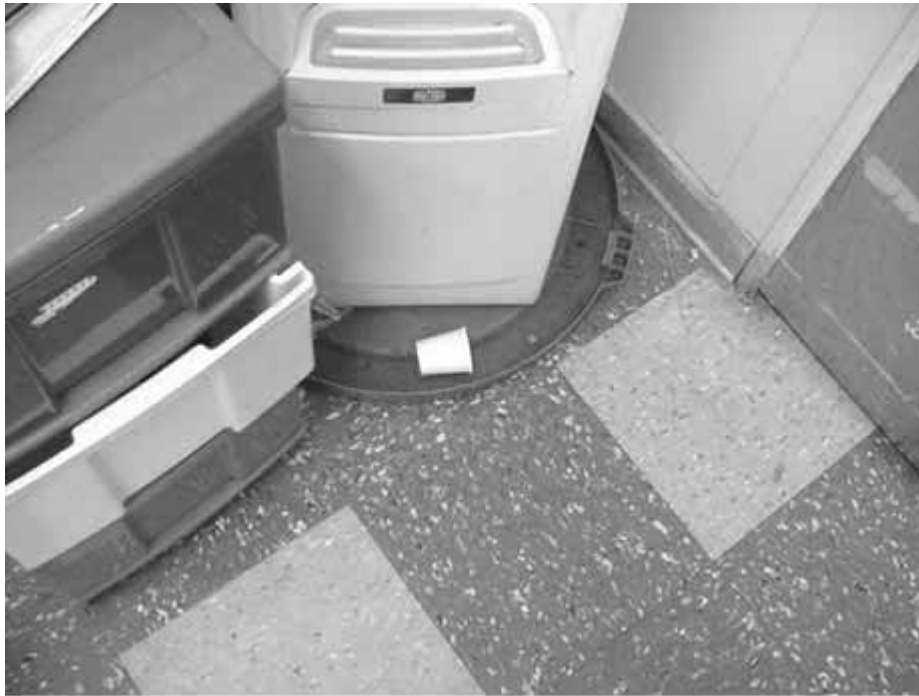
Picture 6

A number of conditions conducive to microbial growth were noted at the HES. Water coolers are located in lounge areas. Standing water and debris were noted in catch basins (Picture 6). Stagnant water can provide a medium for bacterial and microbial growth. To prevent growth, catch basins should be emptied and cleaned regularly.

Water cooler on plastic cover with standing water and debris

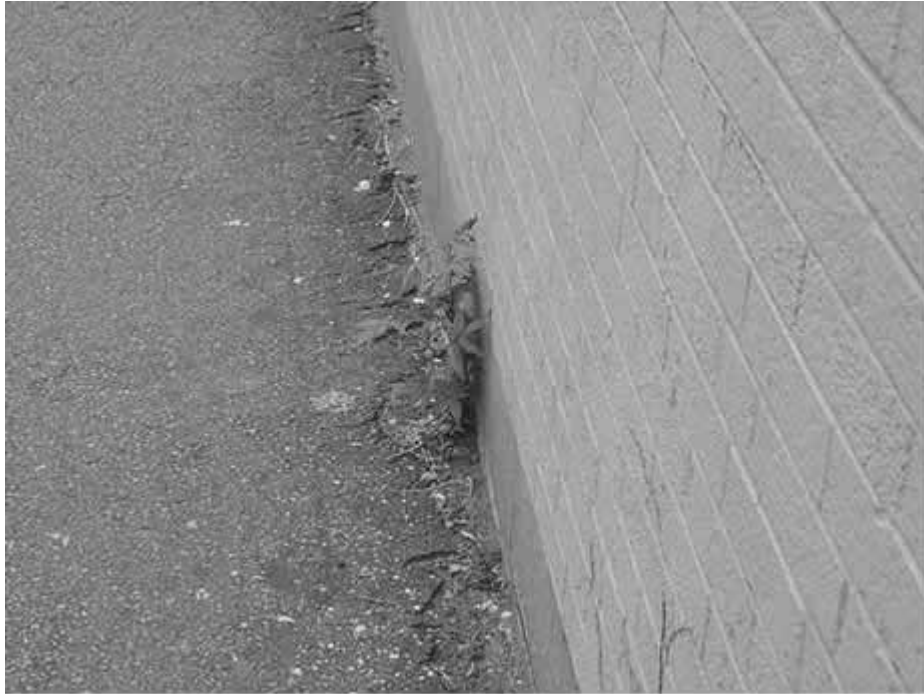
Picture 7a

Shrubbery, plants and fungi were growing in close proximity to the foundation walls (Pictures 7a and 7b). Fungi growth is an indication of high moisture content, and that some portions of the landscape have experienced water accumulation. Roots growing

against the exterior walls can bring moisture in contact with wall brick and eventually lead to cracks and/or fissures in the foundation below ground level. Over time, this process can undermine the integrity of the building envelope and provide a means of water entry into the building through capillary action through foundation concrete and masonry (Lstiburek & Brennan, 2001).

Plant growth against building foundation

10. Remove plants and weeds that are growing along building foundation and below fresh air intakes.
11. Replace/repair water-stained ceiling tiles and building materials. Examine the area above and around these areas for mold growth. Disinfect areas of water leaks with an appropriate antimicrobial as necessary.

- a) Install gutters and downspouts to direct rainwater at least five feet away from the foundation.
 - b) Remove foliage to no less than five feet from the foundation.

- c) Improve the grading of the ground away from the foundation at a rate of 6 inches per every 10 feet (Lstiburek & Brennan, 2001).
 - d) Install a water impermeable layer on ground surface (clay cap) to prevent water saturation of ground near foundation (Lstiburek & Brennan, 2001).

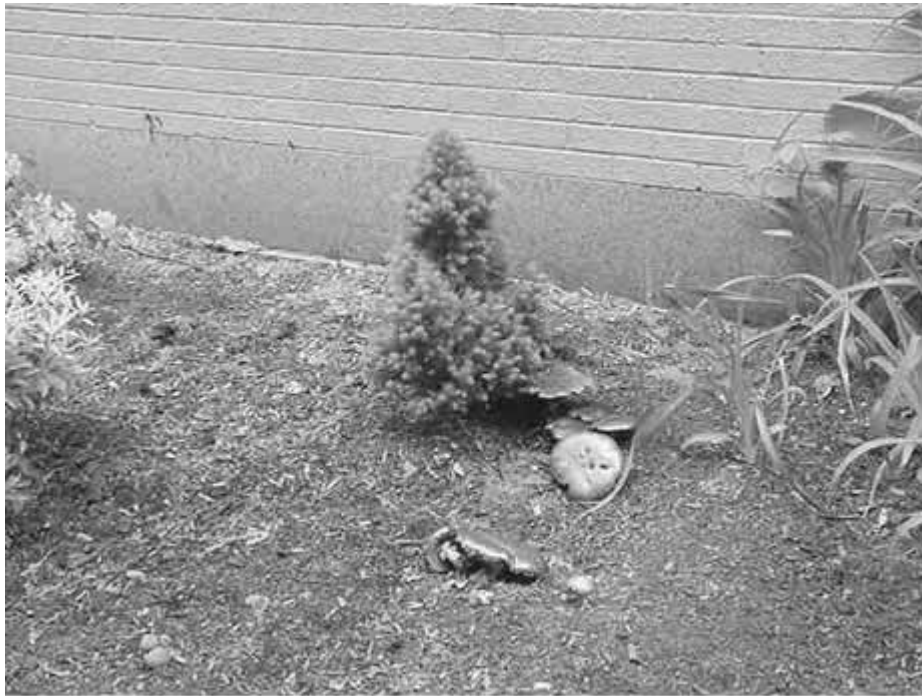
Picture 7b

Fungi growth around school perimeter

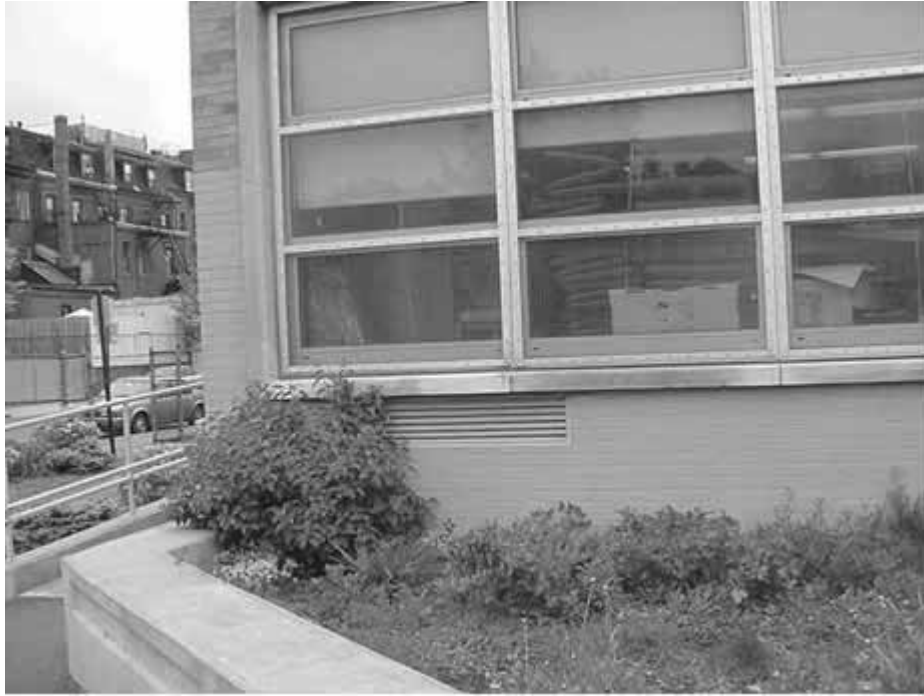
Picture 8

Plants were also noted to be growing beneath univent fresh air intakes along the perimeter of the building (Picture 8). Care should be taken to ensure that fresh air intakes remain clear of obstructions (e.g. snow, shrubbery) to avoid the entrainment of dirt, moisture and or pollen.

Plants located in front of univent fresh air intake

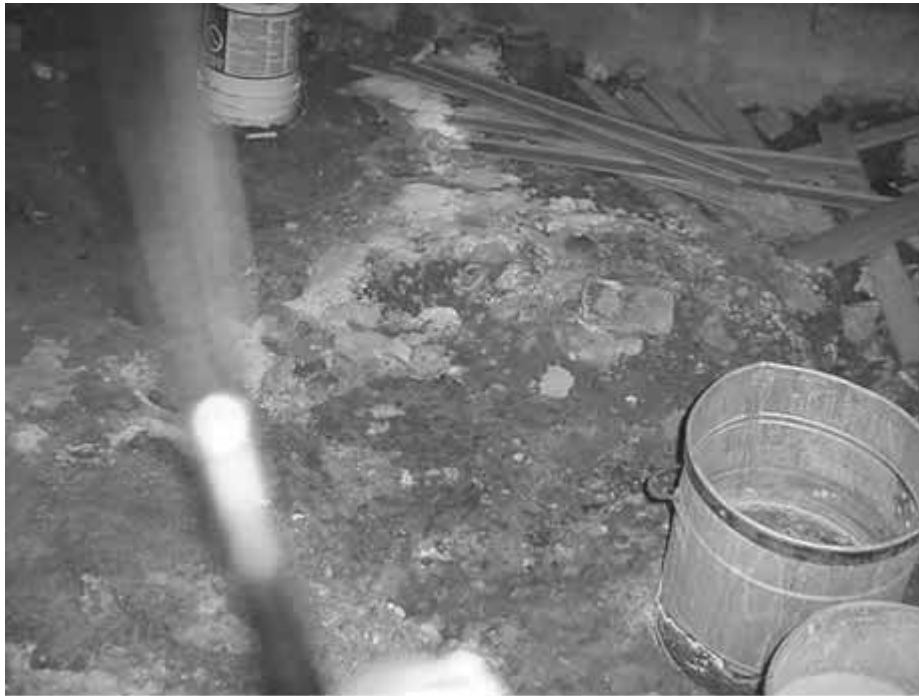
Picture 9

An inspection of the crawlspaces revealed visible mold growth on the soil floor (Picture 9). Standing water was also noted in the crawlspace. An open pipe was seen protruding from the standing water pool (Picture 10). The purpose of the pipe could not be determined. If it were a sewer pipe, sewer gas could penetrate into this section of the crawlspace, particularly during rainstorms. Sewer gas contains different substances that can be eye, nose and respiratory system irritants.

Mold growth on crawlspace floor

12. Consider the following actions as a means to prevent moisture penetration into the crawlspace:

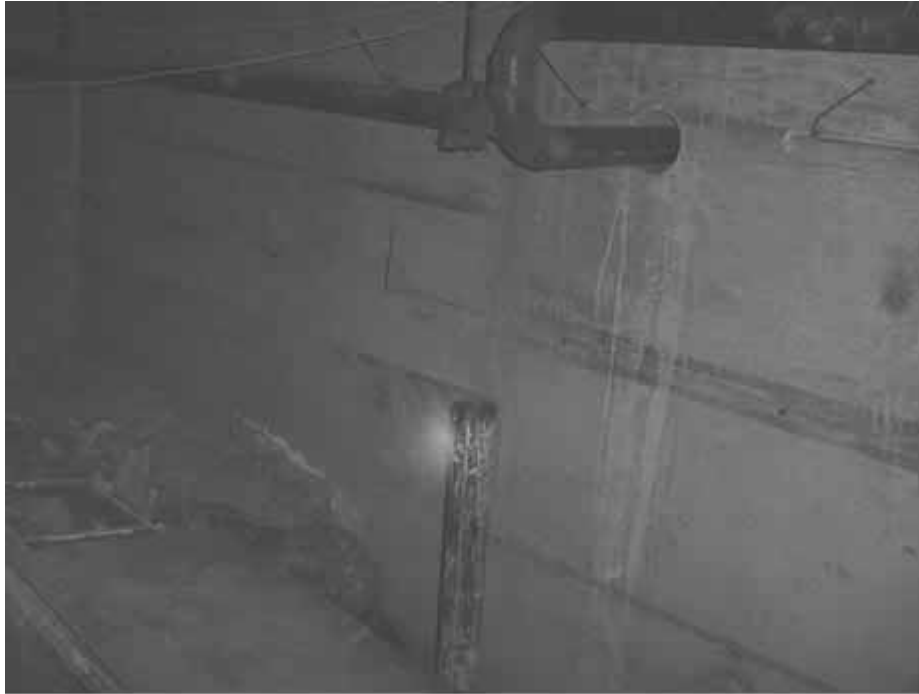
Picture 10

Unsealed pipe protruding from crawlspace floor

- 13. Identify the purpose of the pipe in the crawlspace. Repair, cap or remove as needed.
 - 14. Seal all utility holes, wall cracks and any other possible pathways to prevent the egress of materials into the school.

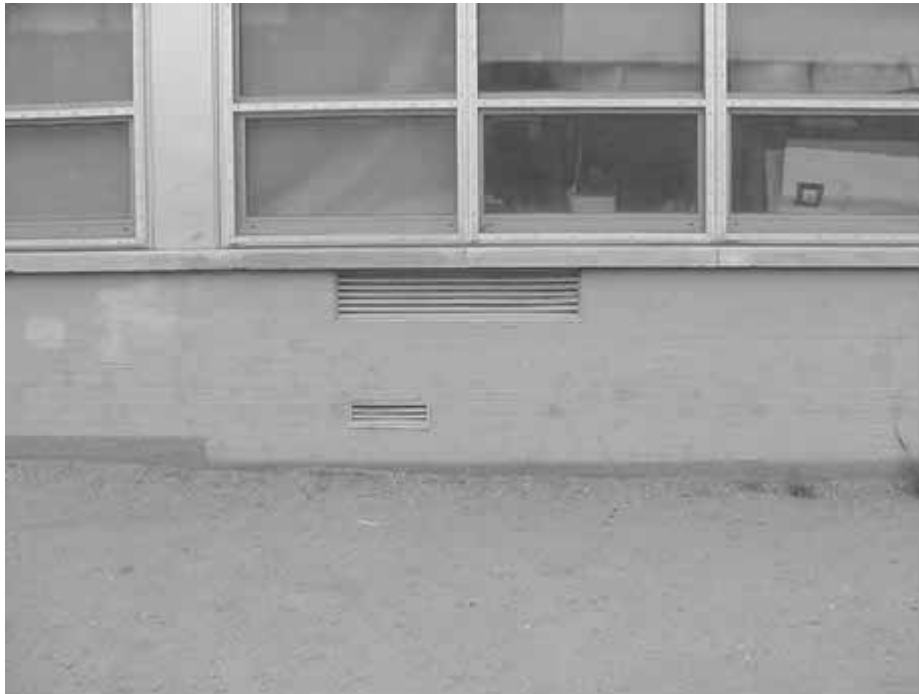
Picture 11

Several pathways exist for crawlspace air to migrate into occupied areas. An exhaust vent for the crawlspace is located directly below a fresh air intake of a classroom

univent (Picture 11). The configuration results in the entrainment of crawlspace exhaust into the classroom. As a result, odors and/or particulates associated with standing water and visible mold growth in the crawlspace can be introduced into the classroom.

Crawlspace exhaust located below univent fresh air intake

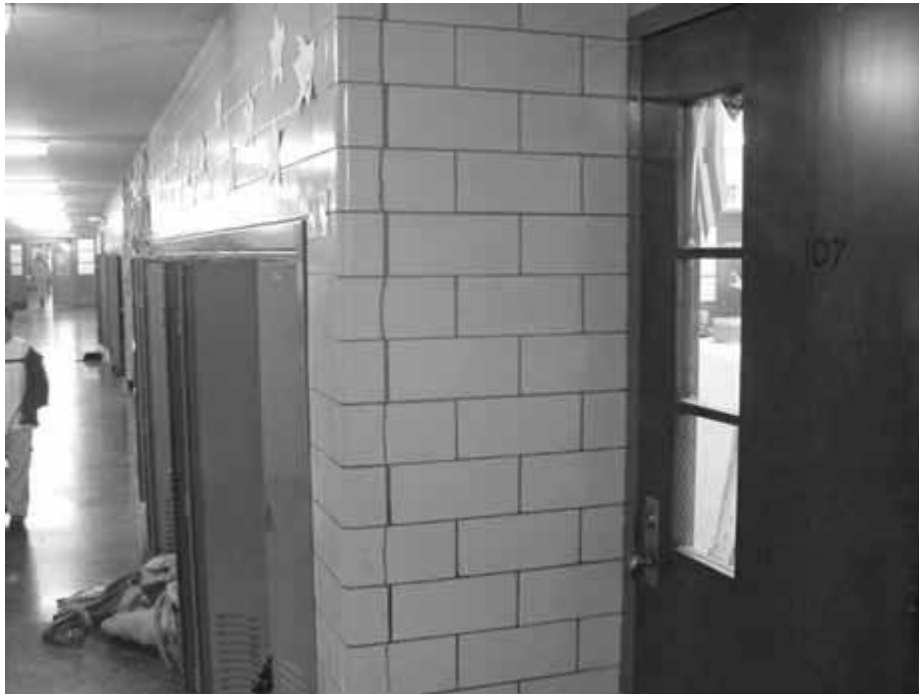
Picture 12

Lastly, a seam was located along the wall outside of classroom 107 (Picture 12). An abandoned vent was also noted in a stairwell (Picture 13). These breaches can serve as pathways for air, odors and particulates to be drawn into occupied from exterior wall cavities and the crawlspace. A seam was also noted between two adjoining exterior walls (Picture 14). Under driving rain conditions, water can penetrate the building through the seam.

Seam in wall outside classroom 107

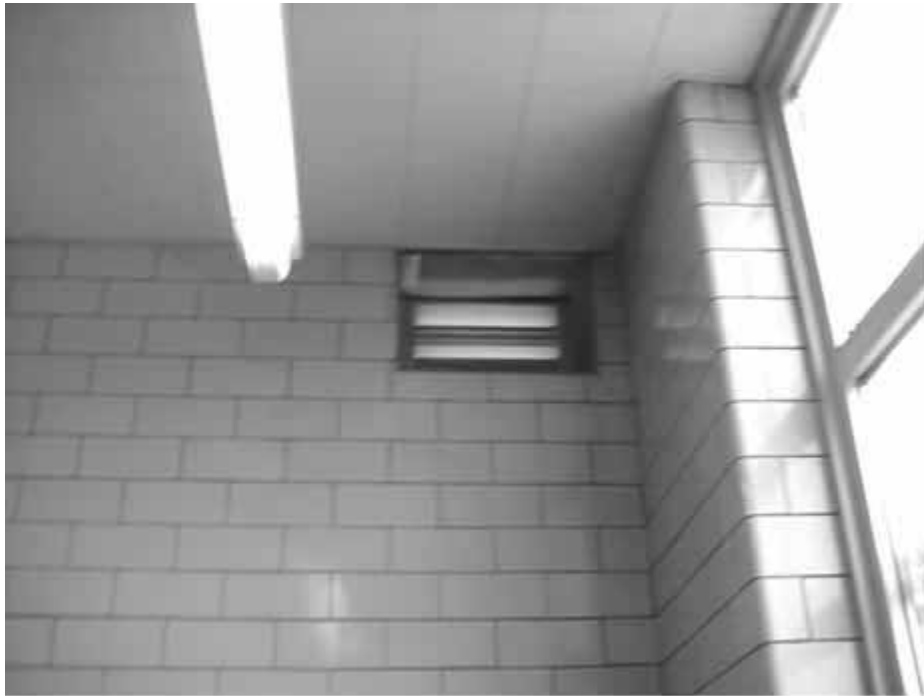
Picture 13

Abandoned vent in stairwell

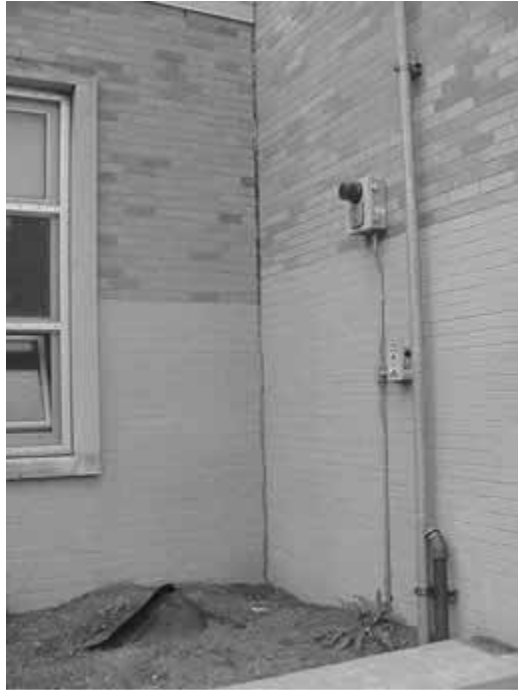
Picture 14

Seam between two adjoining walls in building exterior

- 15. Consider having exterior brick re-pointed and waterproofed to prevent water intrusion.
 - 16. Consider having upholstered furniture cleaned professionally on an annual basis.

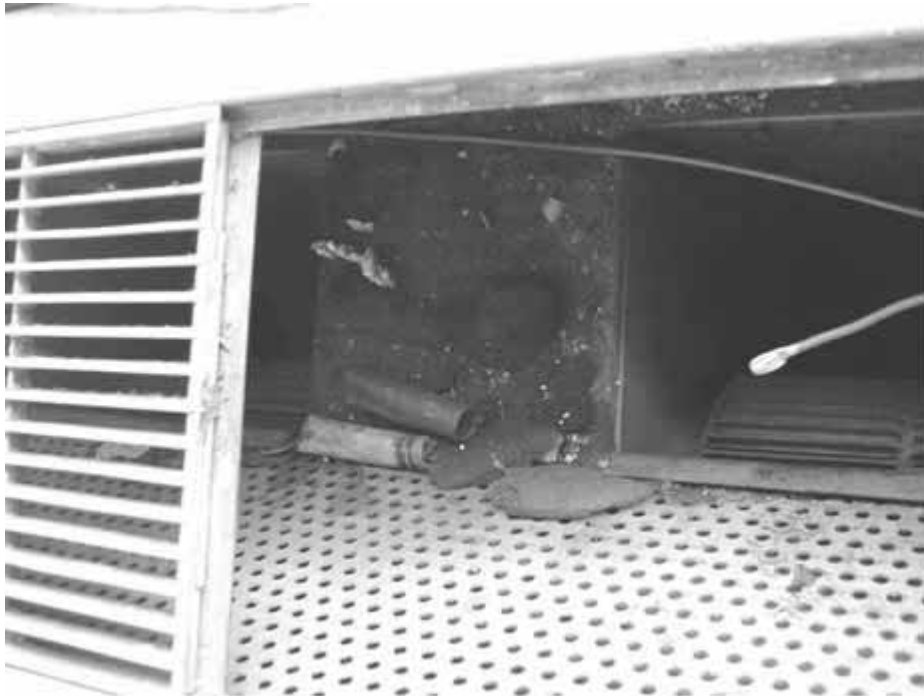
Picture 15a

Several other conditions that can affect indoor air quality were noted during the assessment. A noticeable, slightly irritating odor was detected upon BEHA staff entry into the building. This odor was traced to a univent that had melted crayons inside the air diffuser, as well as in vents connected to the axial fans (Picture 15a and 15b). Univents in this building are designed to provide heated fresh air during cold weather. In this instance, the operation of the univent heats and melts crayons to produce fumes. The odors are then distributed into the classroom and adjacent hallway. The presence of crayon residue inside

univents provides a reservoir of materials that, if not remediated, will continue to produce irritating fumes. The Material Safety Data Sheet for Crayola® crayons indicates that if this product were melted, the procedure should be conducted in a well-ventilated area. (Binney & Smith, 2002). “Overheating wax crayons during melting or ironing may release irritating fumes” (Binney & Smith, 2002).

Crayons in univent

6. Remove crayon residues from univents. Prevent students from inserting crayons into univents.
7. Adopt scrupulous cleaning practices. For buildings in New England, periods of low relative humidity during the winter are often unavoidable. Therefore, scrupulous cleaning practices should be adopted to minimize common indoor air contaminants whose irritant effects can be enhanced when the relative humidity is low. Drinking water during the day can help ease some symptoms associated with a dry environment (throat and sinus irritations).

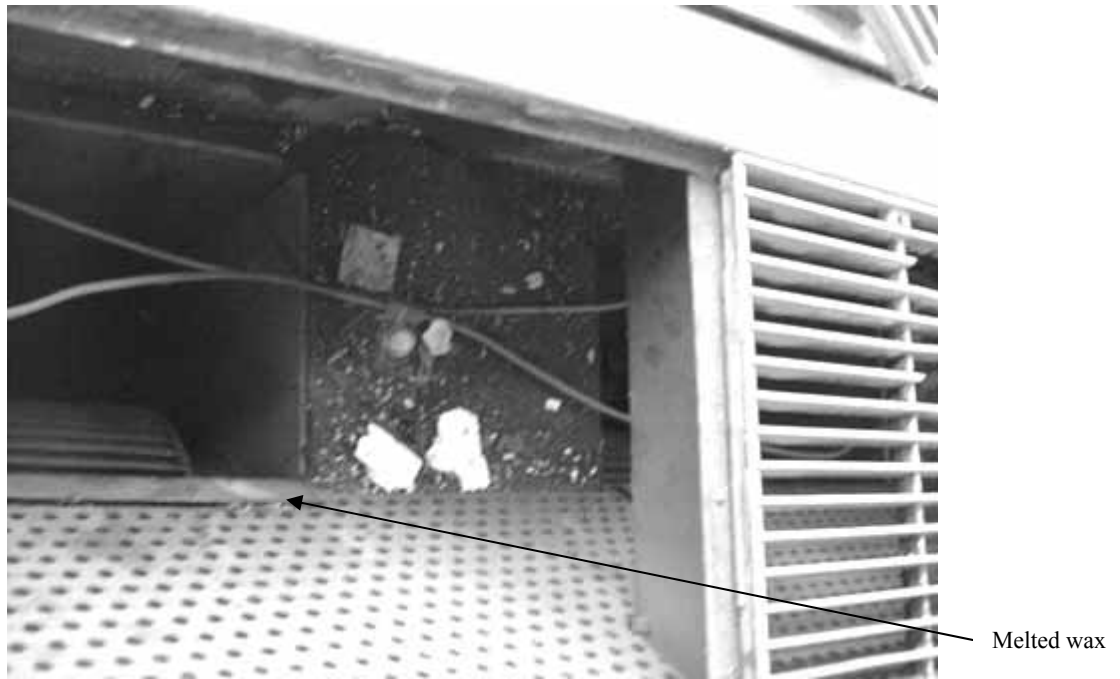
Picture 15b

Melted crayon wax in univent

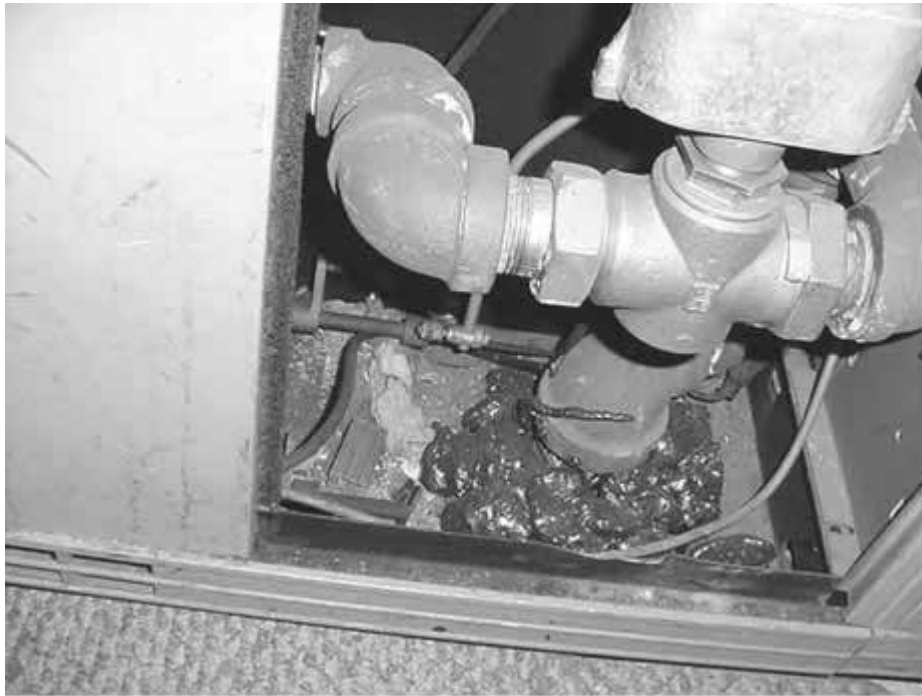
Picture 17

In efforts to eliminate pest problems, rodenticide was placed in univent chambers (Picture 17). The rodenticide was not in bait trays. Instead, the bait was placed in the univent chamber near an uninsulated pipe, which is connected to the heating coil. No melted rodenticide pellets were noted; however, an inquiry with the contractor concerning temperature stability of this product should be explored. If these matrices are thermally unstable at temperatures maintained by the heating pipes, the wax can melt and potentially produce fumes. Airflow through the univent could subsequently aerosolize rodenticide components.

Rodenticide near heating pipe

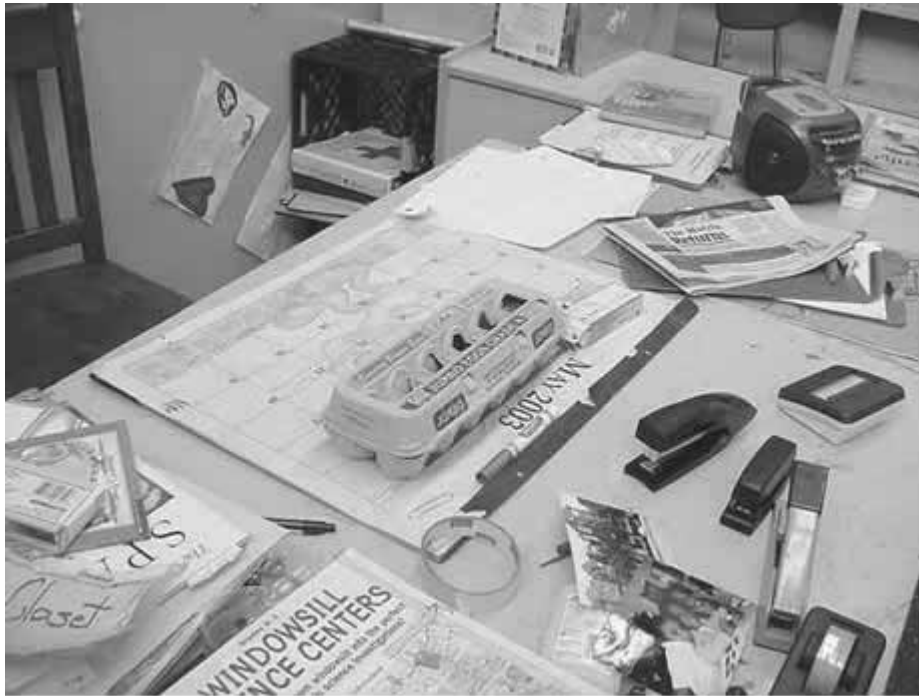
Picture 18

Use of rodenticides alone cannot prevent pest and rodent problems. Food is an attractant to pests and rodents. Food was found in open areas (Picture 18). In addition, food sacks found in the basement were reused to store rock salt (Picture 19). As previously discussed, proper food storage is an integral component in maintaining sanitary conditions. Reuse of food containers is not recommended, since food residue adhering to the surface may serve to attract pests.

Food stored in open area

- c) Store foods in tight fitting containers.
 - d) Avoid eating at work stations. In areas where food is consumed, periodic vacuuming to remove crumbs is recommended.

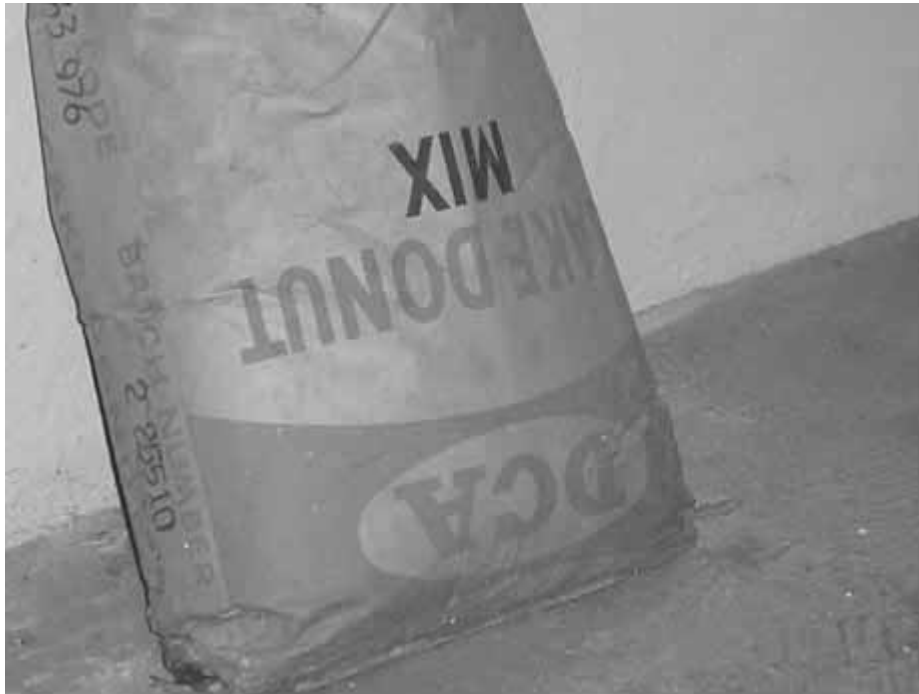
Picture 19

Rock salt stored in cake donut mix sack

- a) Rinse out recycled food containers. Seal recycled containers in a tight fitting lid to prevent rodent access.
 - b) Remove non-food items that rodents are consuming.

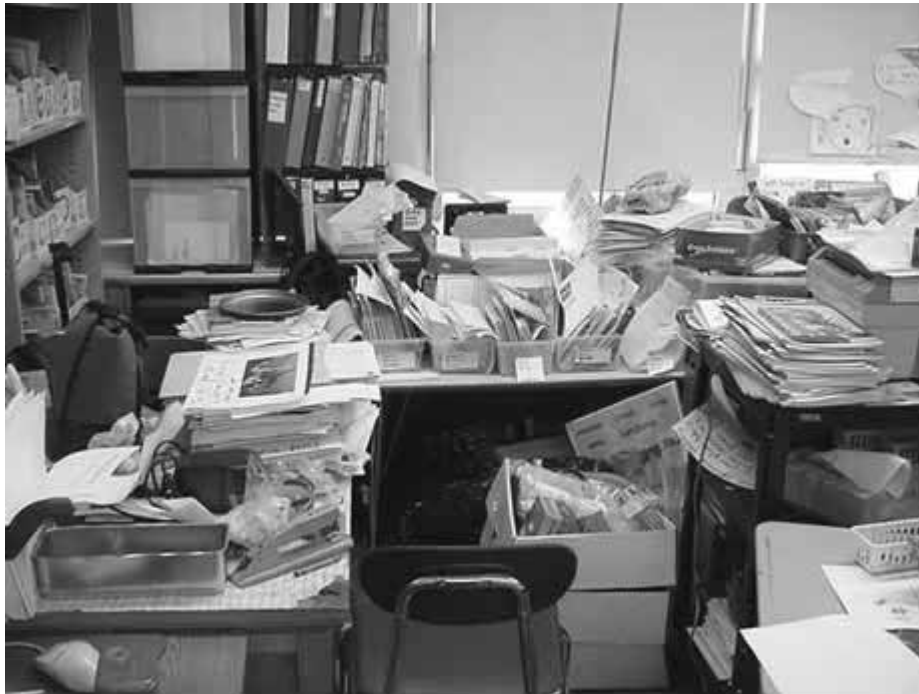
Picture 20

Also of note was the amount of materials stored inside classrooms (Picture 20). In classrooms throughout the school, items were seen on windowsills, tabletops, counters, bookcases and desks. The large amount of items stored in classrooms provides a means for dusts, dirt and other potential respiratory irritants to accumulate. Many of the items, (e.g. papers, folders, boxes) make it difficult for custodial staff to clean. A number of exhaust vents in classrooms were also noted with accumulated dust (Picture 21). Back drafts can result in re-aerosolization of accumulated dust particles. Dust can be irritating to the eyes, nose and respiratory tract.

Organization and storage of materials in classroom

- 17. Relocate or consider reducing the amount of materials stored in classrooms to allow for more thorough cleaning. Clean items regularly with a wet cloth or sponge to prevent excessive dust build-up.

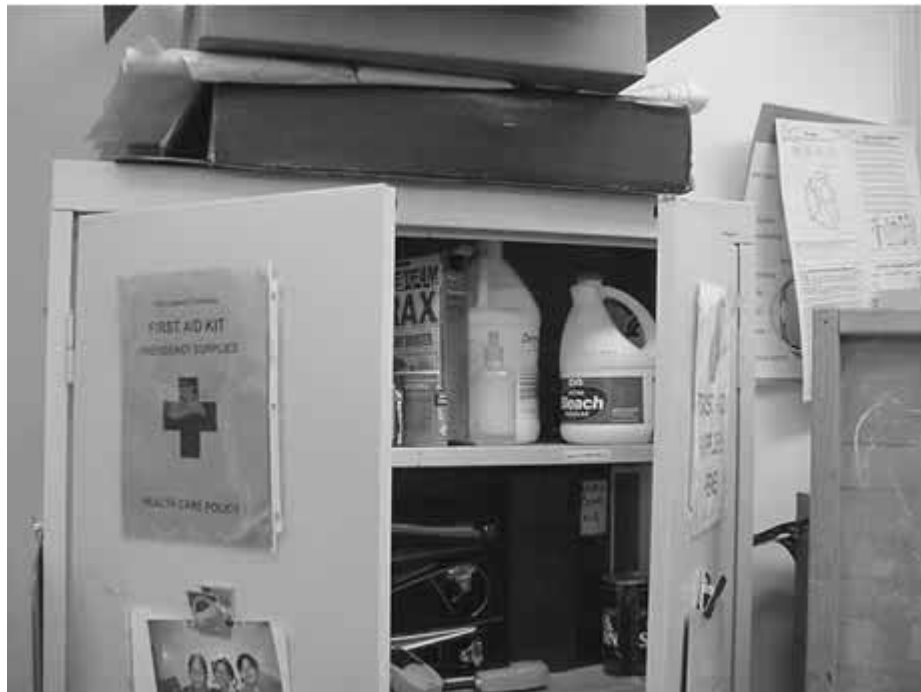
Picture 22

Cleaning products and other chemicals were found in floor level cabinets and on counter tops in several classrooms. In one instance, cleaning products were found in a first-aid cabinet (Picture 22). Cleaning products contain chemicals, such as bleach or ammonia-related compounds, that can be irritating to the eyes, nose and throat. These items should be stored properly and out of the reach of students.

Cleaning agents stored in first-aid cabinet

- 18. Store cleaning products properly and out of reach of students.
 - 19. Clean chalkboards and trays regularly to avoid the build-up of excessive chalk dust.

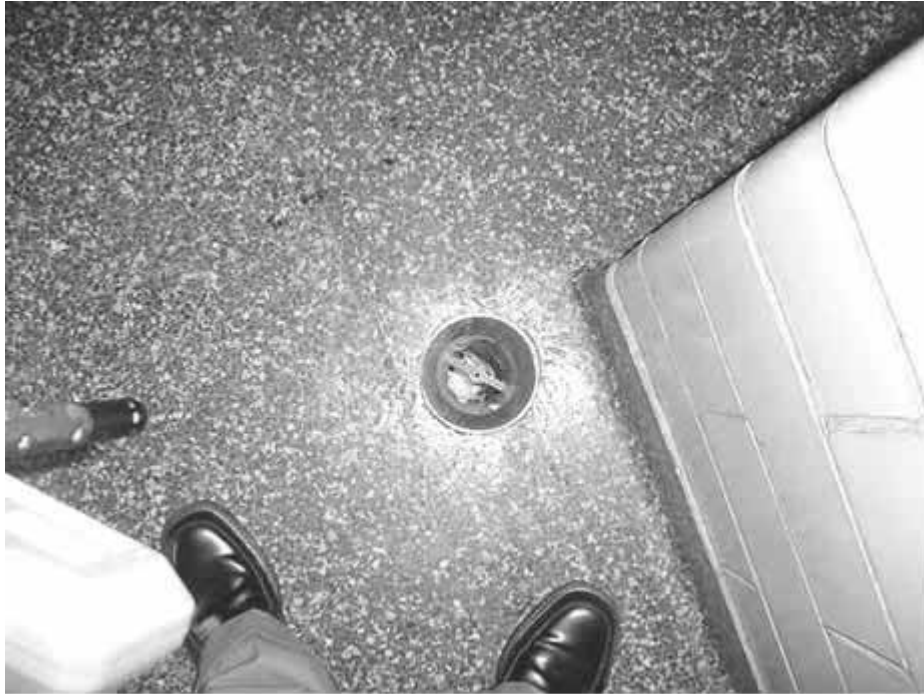
Picture 23

Bathrooms on each floor are equipped with floor drains. Drains did not appear to have recently drained water, which can lead to dry traps. In addition, a floor drain in the first floor girls' bathroom was blocked with debris because it was missing a drain cover (Picture 23). A trap forms an airtight seal when water is poured down the drain. A dry trap can allow for sewer gas to back up into the building. Sewer gas can be irritating to the eyes, nose and throat.

Drain with missing drain cover in the first floor girls' bathroom

- 20. Install local exhaust ventilation in the main office to prevent build up of VOCs and excess heat produced by photocopiers.
 - 21. Ensure drain covers are installed on all floor drains and pour water down drains regularly to prevent dry traps and associated odors.
